## 2004 / 2005 NAPL SURVEY RESULTS Remedial Investigation Report

Sauget Area 1  
Sauget and Cahokia, Illinois

GSI Job No.	G-3385	Drawn By:	CDM
Map ID:	000_03	Chk'd By:	JAK
Issued:	25-May-12	Apr'd:	JAK
Scale:	As Shown	<b>Figure 4-3</b>

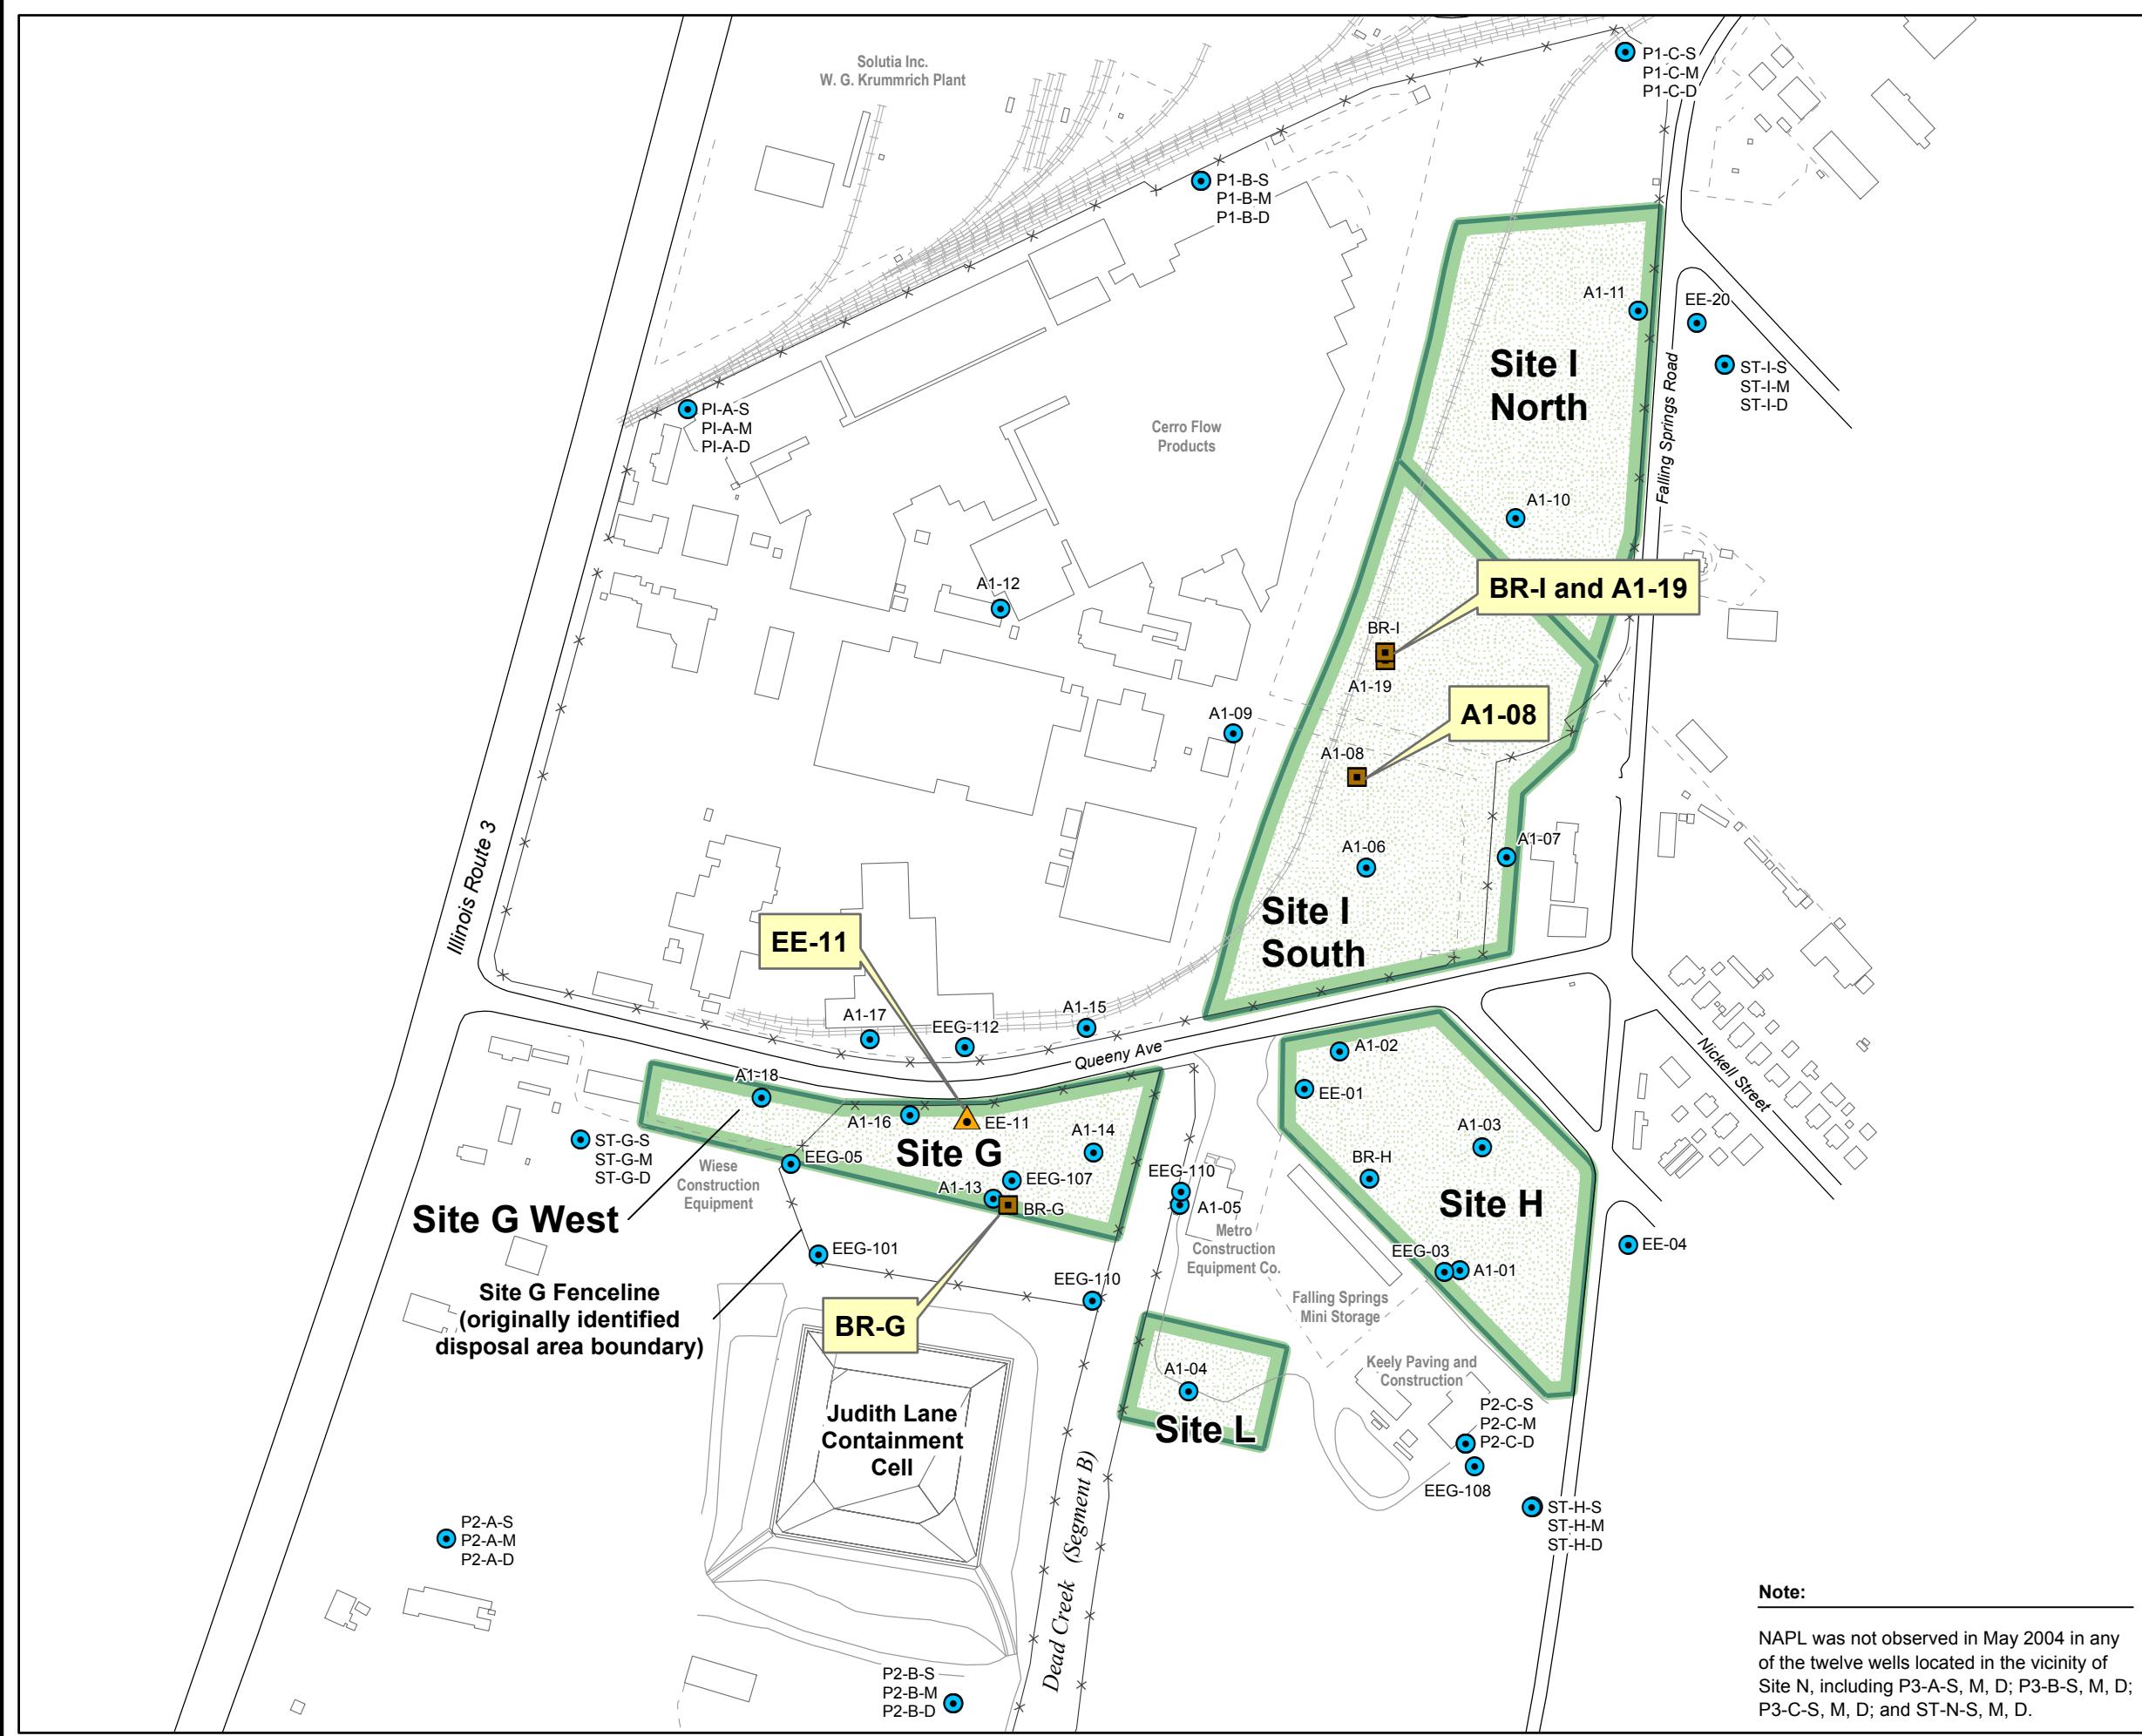
### Results of NAPL Surveys Performed in 2004 and 2005

**BR-I and A1-19:** An accumulation of pooled DNAPL was consistently observed in BR-I during well surveys performed in 2004 and 2005. Some pooled DNAPL was recovered from BR-I by pumping. An accumulation of pooled DNAPL was observed in A1-19 after this well was installed in October 2005.  
*Conclusion - Pooled DNAPL is present at BR-I and A1-19.*

**A1-08:** Droplets of DNAPL were noted during a well survey in October 2004, but no evidence of DNAPL was observed during a well survey in September 2005.  
*Conclusion - Pooled DNAPL is not present at A1-08.*

**BR-G:** Some evidence of DNAPL was noted during well surveys in May 2004, October 2004, July 2005, and September 2005, but no DNAPL was recovered by pumping in May 2004, October 2004, and September 2005.  
*Conclusion - Some DNAPL is present in BR-G, but recovery of DNAPL by pumping does not appear feasible.*

**EE-11:** A minor accumulation of LNAPL was observed and recovered from this shallow well in May 2004. Some evidence of LNAPL was noted during a well survey in October 2004 but bailing yielded no LNAPL. Some evidence of LNAPL was noted during a well survey in September 2005, but only small globs of LNAPL with water were recovered during pumping.  
*Conclusion - Further recovery of LNAPL at EE-11 by pumping does not appear feasible.*
